Journal of Engineering and Applied Sciences 3 (2007) 57 - 60

Corrosion of surface facilities of an industrial concern in the niger delta area of Nigeria splased by produced water

C. N. Anyakwo

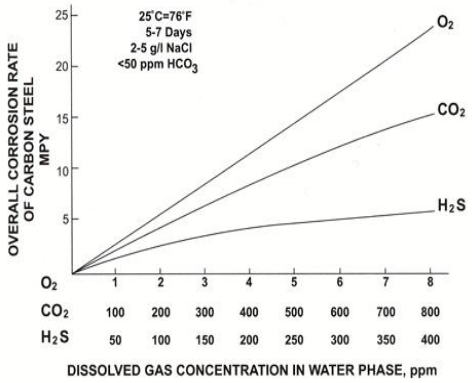
Fig. 2. Dissolved gas concentration in water phase, ppm.

- The steady evolution of hydrogen gas that is provided by carbonic acid dissociation.
- The steady diffusion of the adsorbed hydrogen atoms into the metal with a probable "burrowing" effect.
- The corrosion product detachment or peeling by the formed adsorbed hydrogen gas (see arrow in Fig. 2).
